Case Study

SALT CREEK ELEMENTARY SCHOOL

Problem: Odor Control

Hazardous H₂S Levels Reduced to a Perfect Zero

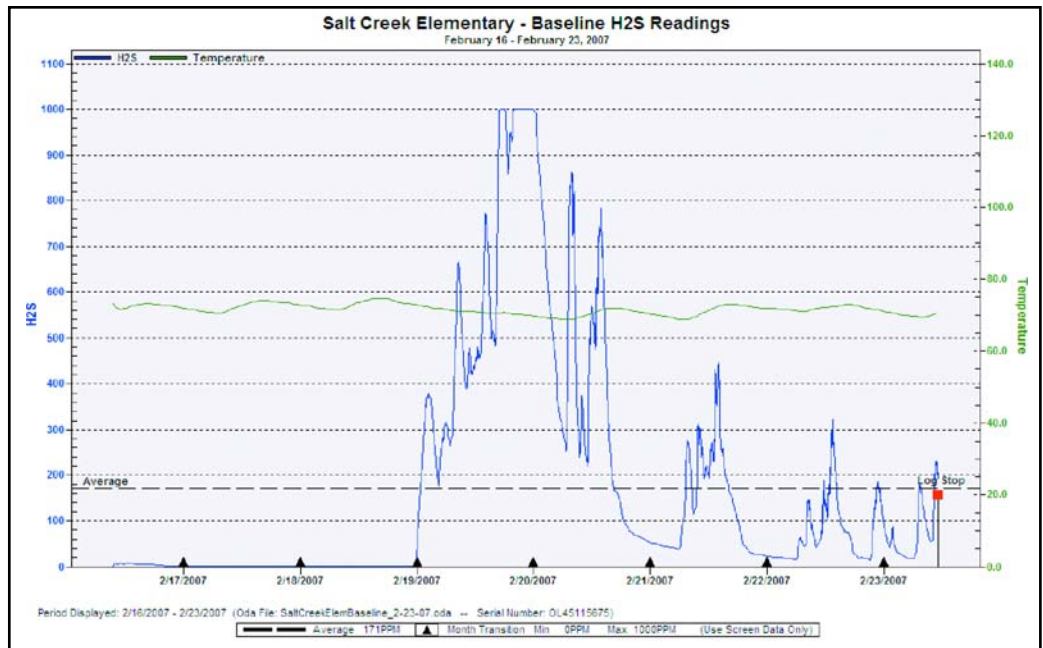
Graph 1 showed zero levels of hydrogen sulfide gas on Friday and Saturday, but when there was some flow generated on Sunday by a school event, the gas levels literally went off the chart. This level of hydrogen sulfide gas is not only offensive smelling, but is actually hazardous, given that the interceptor is located in the heart of the school playground.

Graph 1: Hydrogen sulfide levels are zero on some days and spike dangerously on others.

The BioMagic staff interviewed school district management to get an understanding of the expected flow profile of the interceptor. Combining that information with the data taken from the hydrogen sulfide datalogger, a dosing scheme was devised for adding BioMagic's G6 BioOdorStop to the interceptor. A location for a tank/pump system was found which was out of the kitchen staff's work area, yet close enough to run an injection line into a sink drain which flowed to the interceptor. The interceptor was initially shocked with three gallons of G6 BioOdorStop. The treatment was set to inject G6 BioOdorStop into the interceptor four times per day Monday-Friday, once per day on Saturday, and twice on Sunday in anticipation of students returning on Monday morning.

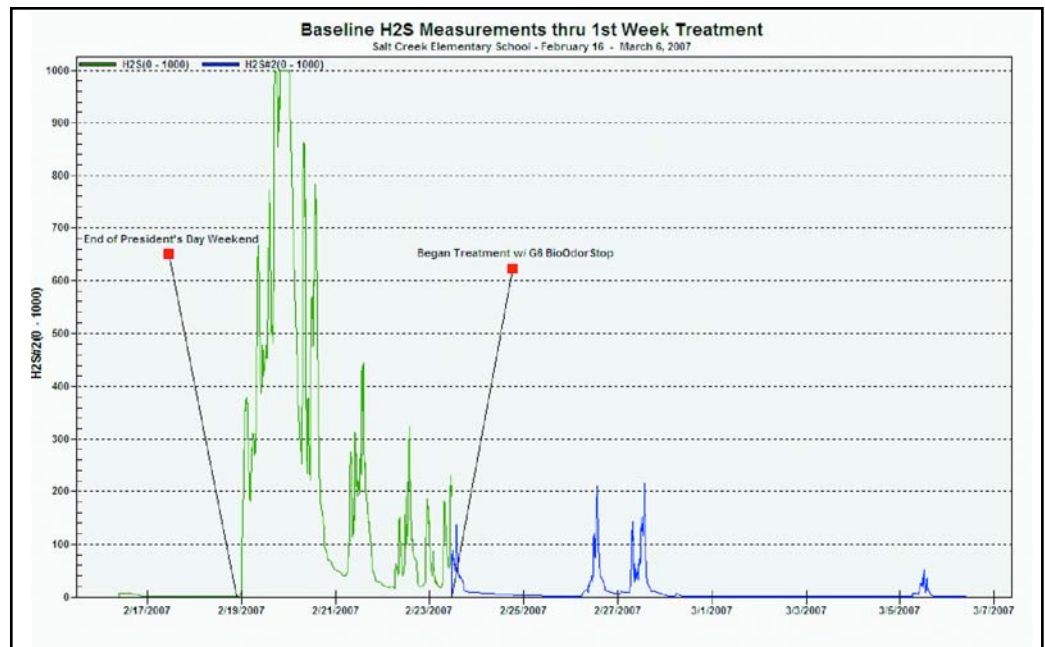
BioMagic staff returned eleven days after the G6 BioOdorStop treatment had begun to evaluate the results of the initial dosing of the interceptor. There had been no odor complaints during the treatment period. The interceptor had been pumped that morning, so no liquid sample could be taken, but the data from the hydrogen sulfide datalogger installed inside the interceptor was downloaded and compared to the original data. See graph 2.

Graph 2: The chart shows the dramatic results achieved during the treatment period, despite several spikes.

It was clear that the hydrogen sulfide levels had been drastically reduced, but there were still a couple of events that needed to be eliminated. The pump was programmed to anticipate the spikes of high gas levels, and the dosing continued. Another datalogger was installed in the interceptor to analyze the modified dosing scheme.

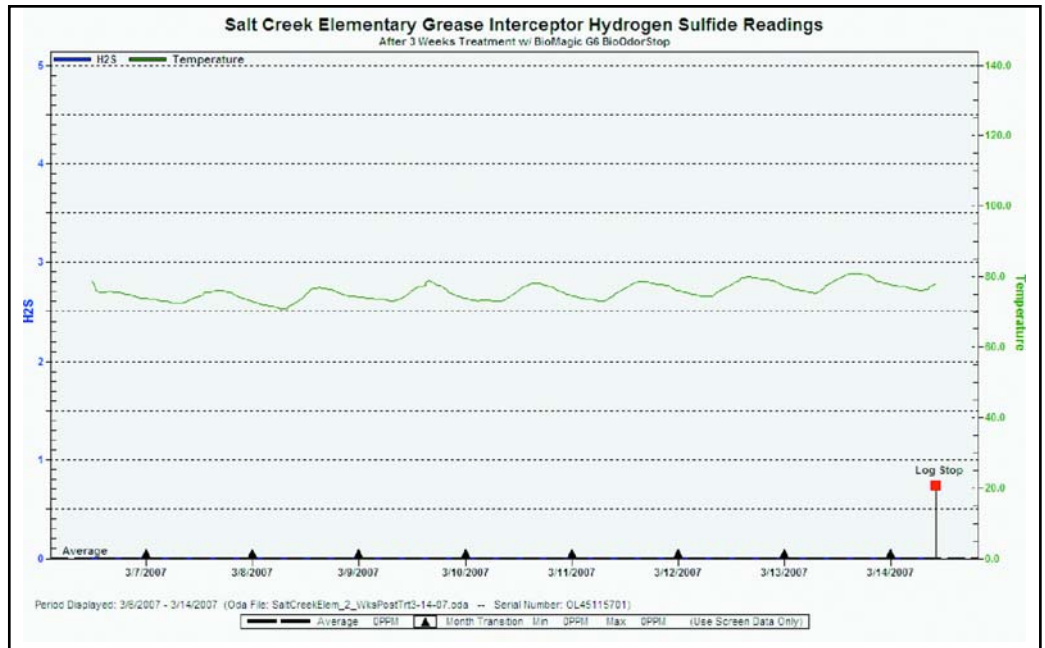
The results were perfect. There was zero measurable hydrogen sulfide gas in the interceptor over the last eight days! (The green line in the chart is temperature; the hydrogen sulfide line is on top of the zero line.) Again, during the last eight days of the modified dosing, there were no odor complaints. The following chart illustrates the change in hydrogen sulfide levels from pre-treatment of the interceptor to just two weeks after treatment began.

Graph 3: The new dosing scheme achieved a perfect result of no hydrogen sulfide gas in the interceptor. The green line in the chart is temperature; the hydrogen sulfide line is on top of the zero line.

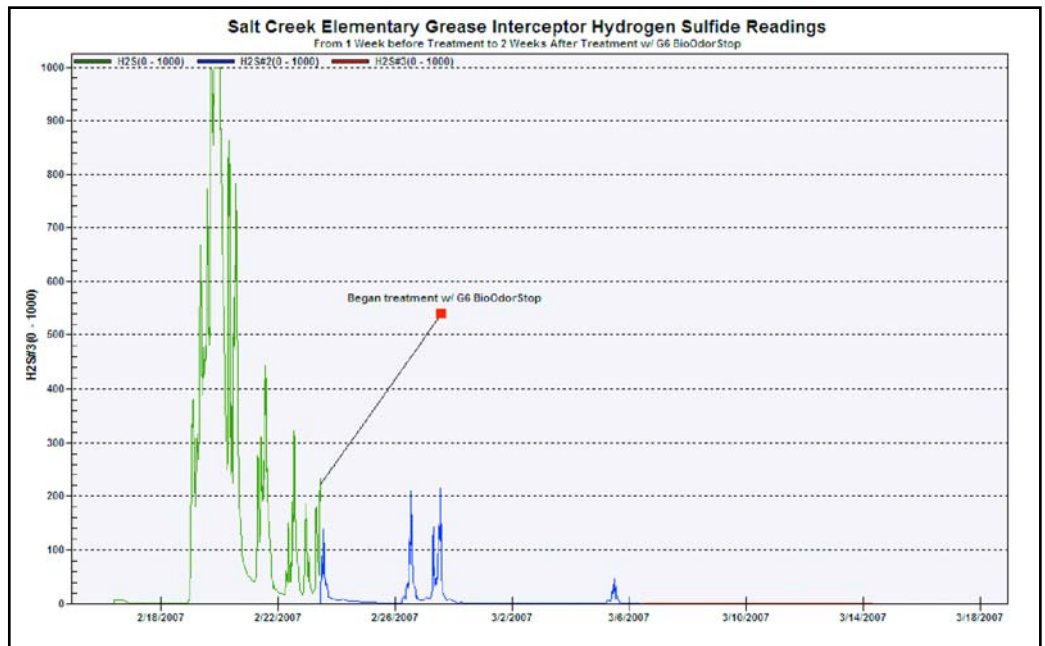
Graph 4: The chart illustrates the change in hydrogen sulfide levels from pre-treatment of the interceptor to just two weeks after treatment began.
