Case Study

TEN ASIAN BISTRO & SUSHI

Problem: Grease Interceptor Odor Control

Fast Action Saves Upscale Reputation

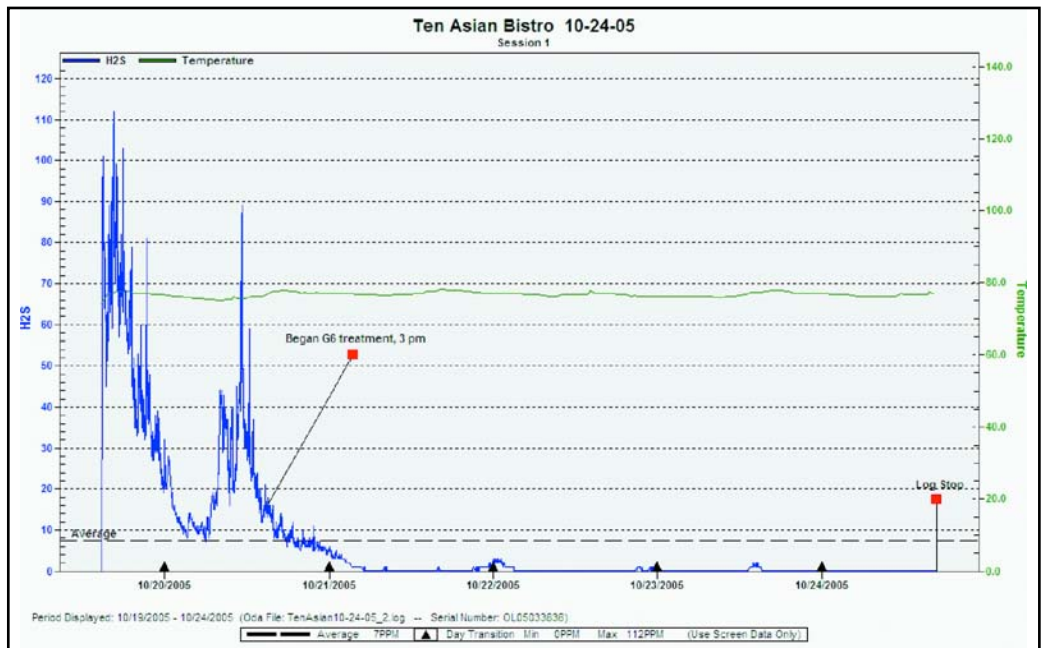
This chart illustrates the effectiveness of the BioMagic treatment. Pre-treatment readings of 33 parts per million of hydrogen sulfide gas were reduced to an average of zero ppm after treatment.

Ten Asian management carefully monitored odor complaints throughout the facility for the next few days. BioMagic staff revisited the restaurant four days later to download the hydrogen sulfide gas data from the datalogger and take liquid samples from the interceptor. After treatment, the liquid sulfide level in the grease interceptor outlet was zero and the average hydrogen sulfide gas levels in the interceptor outlet had dropped to zero parts per million in fewer than 15 hours after treatment had begun.

The quantitative results were very clear: BioMagic's G6 BioOdorStop had eliminated the liquid sulfides in the interceptor and the offensive smelling hydrogen sulfide gases were gone. Ten Asian management was delighted. Not only had the cause of customer complaints been eliminated, but the restaurant was now in compliance with local emission regulations. Most importantly, the restaurant's reputation for being a truly extraordinary dining and entertainment establishment was rescued.
